BRAKE FLUID COMPATIBILITY WITH HARDWARE

INTERIM REPORT TFLRF No. 445

**U.S. Army TARDEC Fuels and Lubricants Research Facility
Southwest Research Institute[®] (SwRI[®])
San Antonio, TX**

May 2014

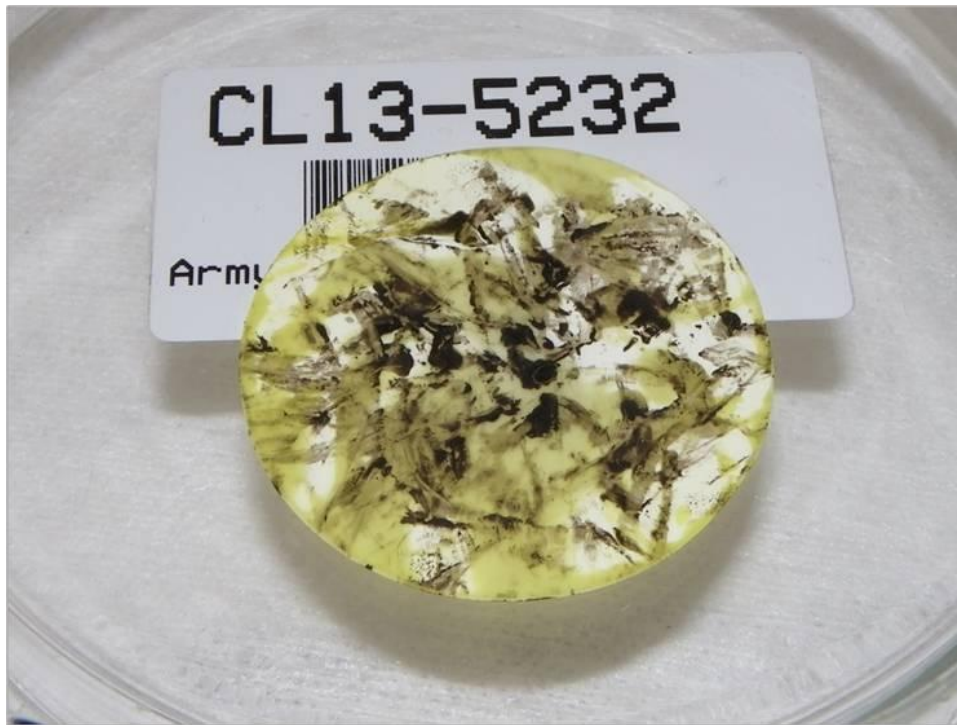
Figure 6. Scraping from HPB Media of Thickened DOT V Fluid after 7,000 Cycles

After 7,000 pump and dump cycles were accumulated with the DOT V fluid it was noted a dark viscous fluid appeared to cover the filter mesh, but particulate did not appear evident. There was not any evidence of particulate formation plugging the filter screens. There did appear to be an “ink-like” viscous fluid on the screens that was believed to be the dye for the fluid. A sample of the “ink-like” fluid was scraped off a section of the HPB filter media and onto a glass fiber filter paper as shown in Figure 6. Examination under a microscope revealed dark and metallic particles were suspended in the thickened liquid, Figure 7.

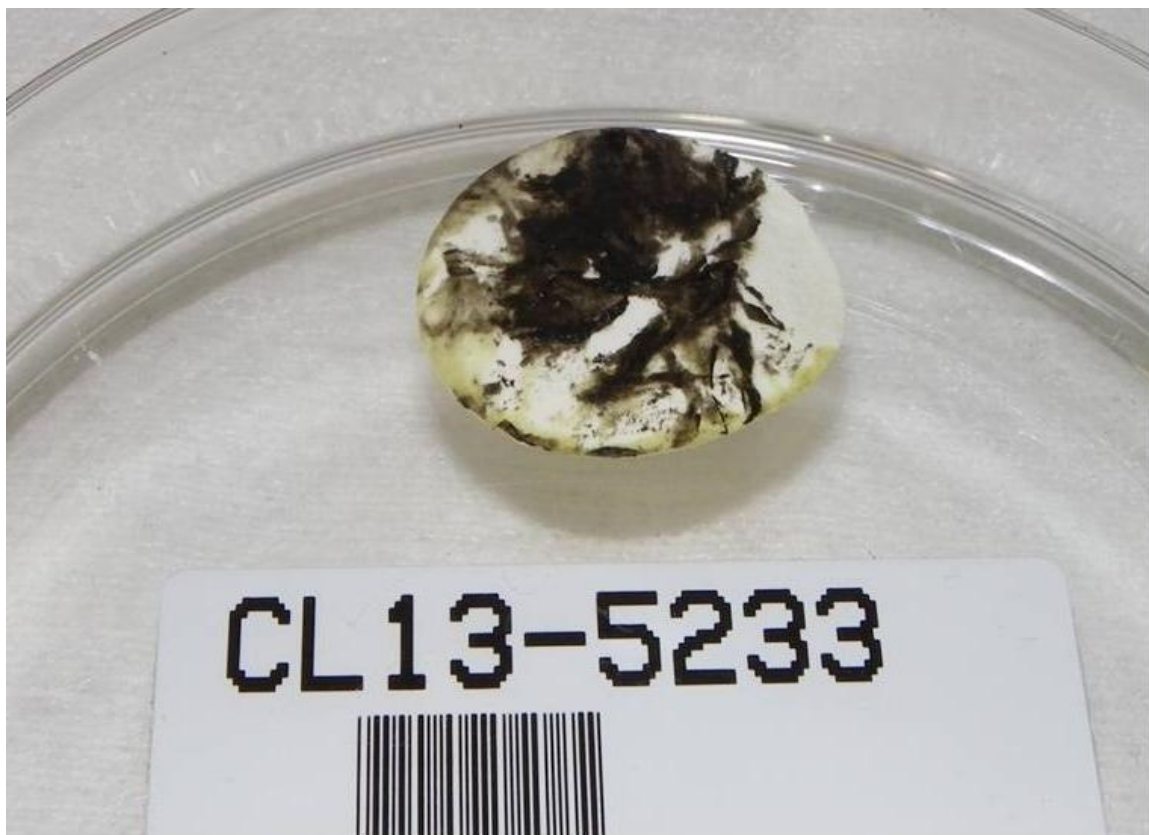
Figure 11. Scraping from HPB Media of Thickened DOT V Fluid after 11,000 Cycles

thickened fluid evident at 7,000 cycles was also present, and appeared to be heavier, but did not appear to compromise the filter media. Another scraping was made of the thick fluid, and transferred to glass fiber filter media. The thickened fluid at 11,000 cycles is shown in Figure 11.

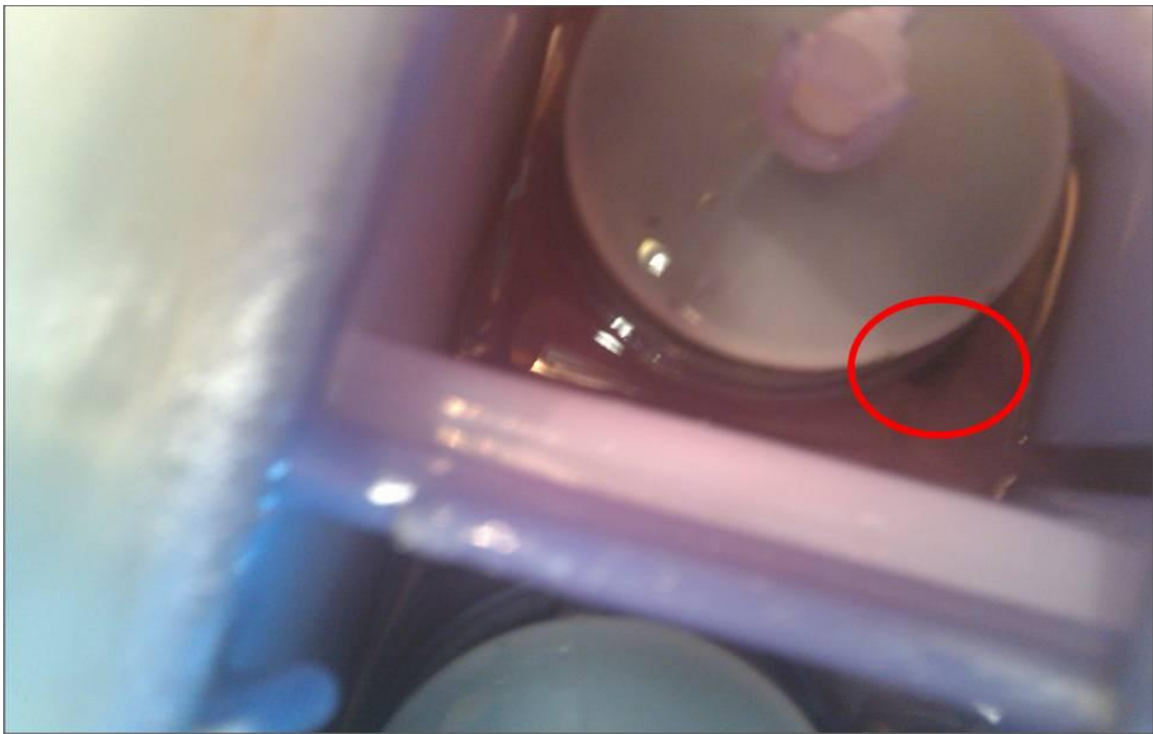
Figure 14. HPB Reservoir with Particle Accumulation Evident after 15,000 Cycles

formation in the HPB reservoir. The particulates formed are shown in Figure 14, indicated by the ellipse, as seen in the emptied reservoir. There was not sufficient particulate formed to cause a compromise of the filter media as noted by the manufacturer in prior testing. A pipette was used to withdraw the particulate and the remaining 50-ml of fluid from the HPB reservoir. The 50-ml of fluid was filtered through a 0.7-micron glass fiber filter to capture any particles as shown in Figure 15. The large flake like particle is likely some of the thickened fluid from the HPB filter that was transferred by the pipette. The fluid prior to filtering did appear to have a grayish tint, which usually indicates black particulate is present. The filter media was examined under magnification and black particulate was present along with evidence of metallic particles as shown in Figure 16.

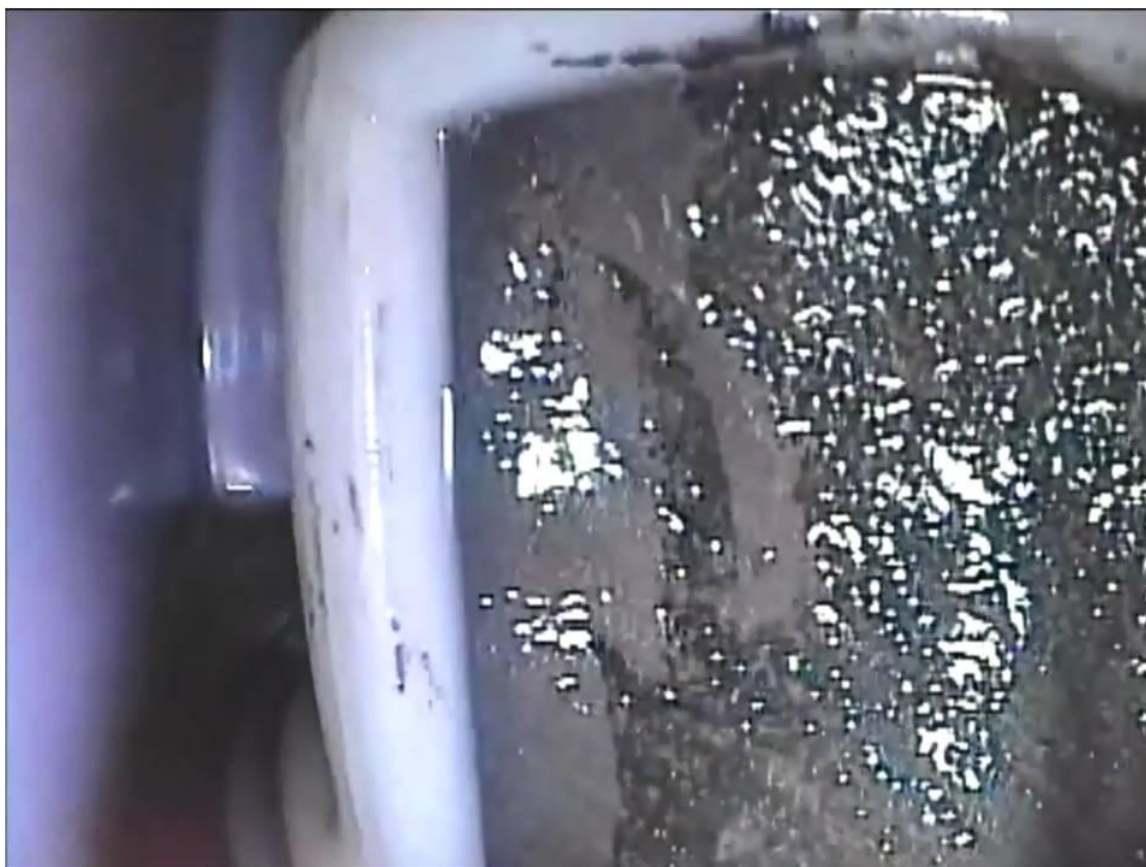
Figure 21. Image Capture From Filter Inspection Video, Revealing Deposits and Viscous Fluid Buildup

The image shown in Figure 21 is a frame capture from the inspection video of a window of one of the two HPB filters, revealing the accumulation of deposits and viscous fluid. The heaviest accumulation of viscous fluid and deposits are shown in Figure 22 from the second HPB filter. Those shown in Figure 22 are the heaviest of the deposits noted from either of the inspection videos. Although the deposits appeared heavy, and the filter media was wrinkled due to elevated differential pressure, the filter integrity had not been compromised.

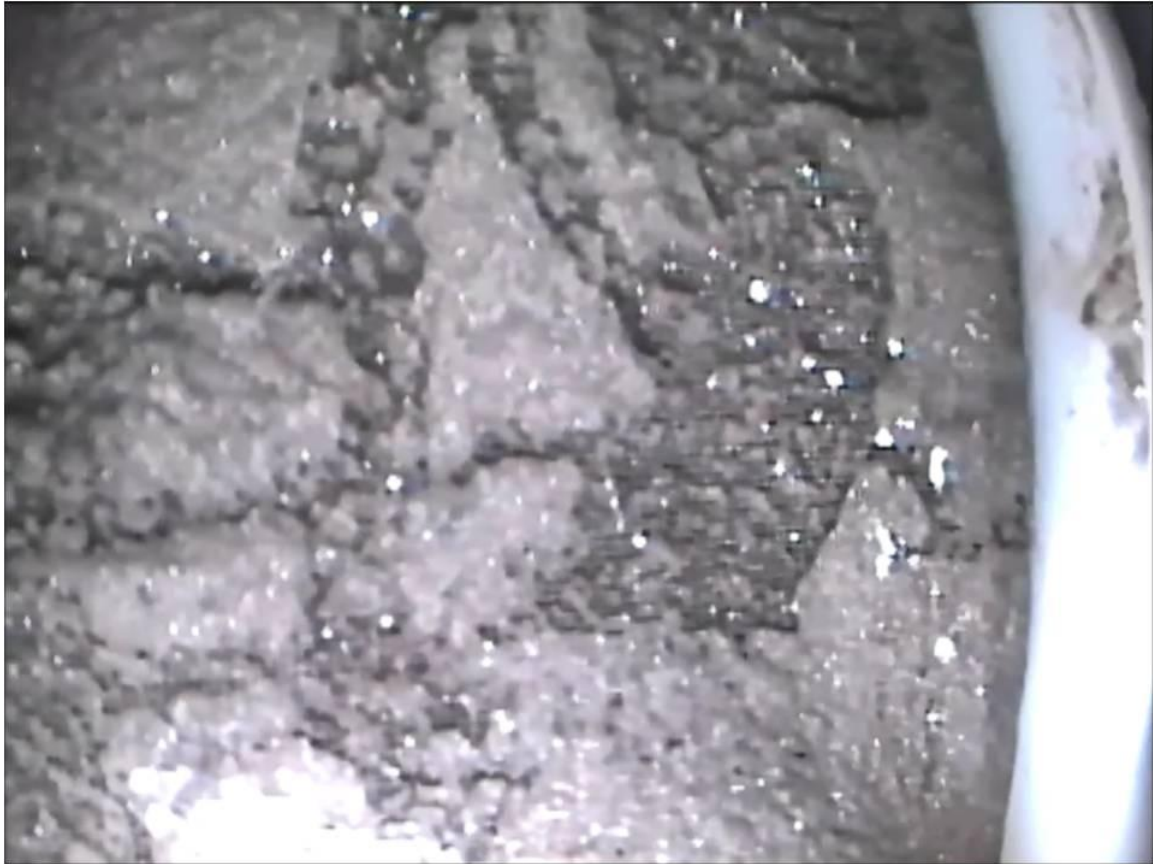
Figure 22. Heavy Deposition Noted on HPB Filter Media After 20,000 Cycles

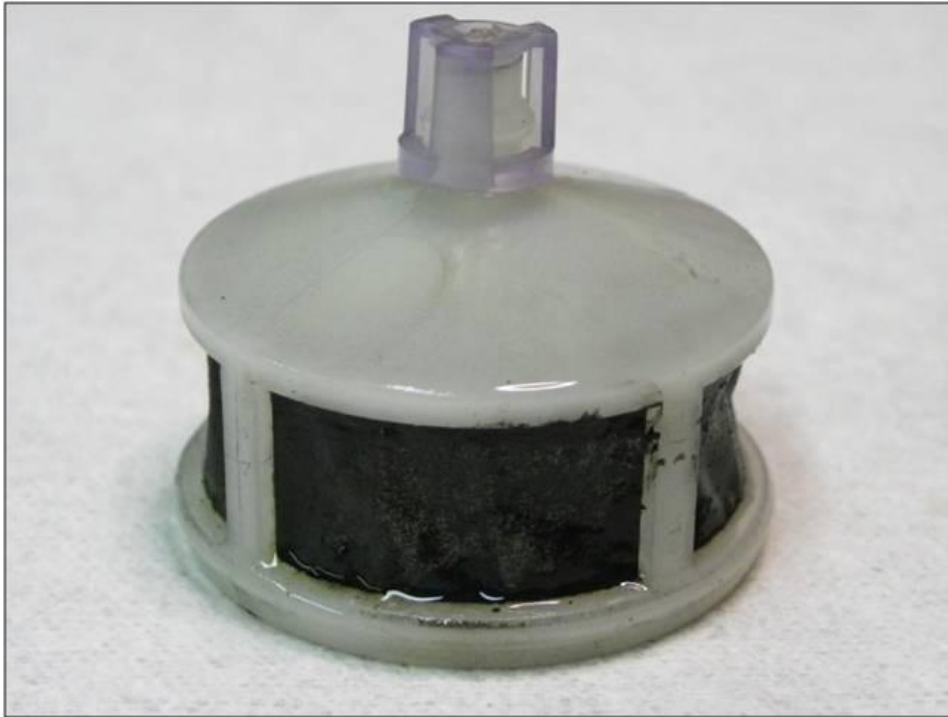
Figure 24. One of Two HPB Filter Elements with Accumulated Particulate Residue From DOT V Fluid Testing

Discussions were held with TARDEC on how to proceed with future testing and analysis. The HPB was disassembled and the pumping elements, filters, and internal components reserved for future inspections for wear and deposits. A pumping element assembly from the DOT V fluid testing is shown in Figure 23. There are new pumping elements available for condition comparison. Samples of new fluid and 20,000-cycle fluids and a filter element with accumulated residue, Figure 24, were shipped to a chemical manufacturer for analysis.

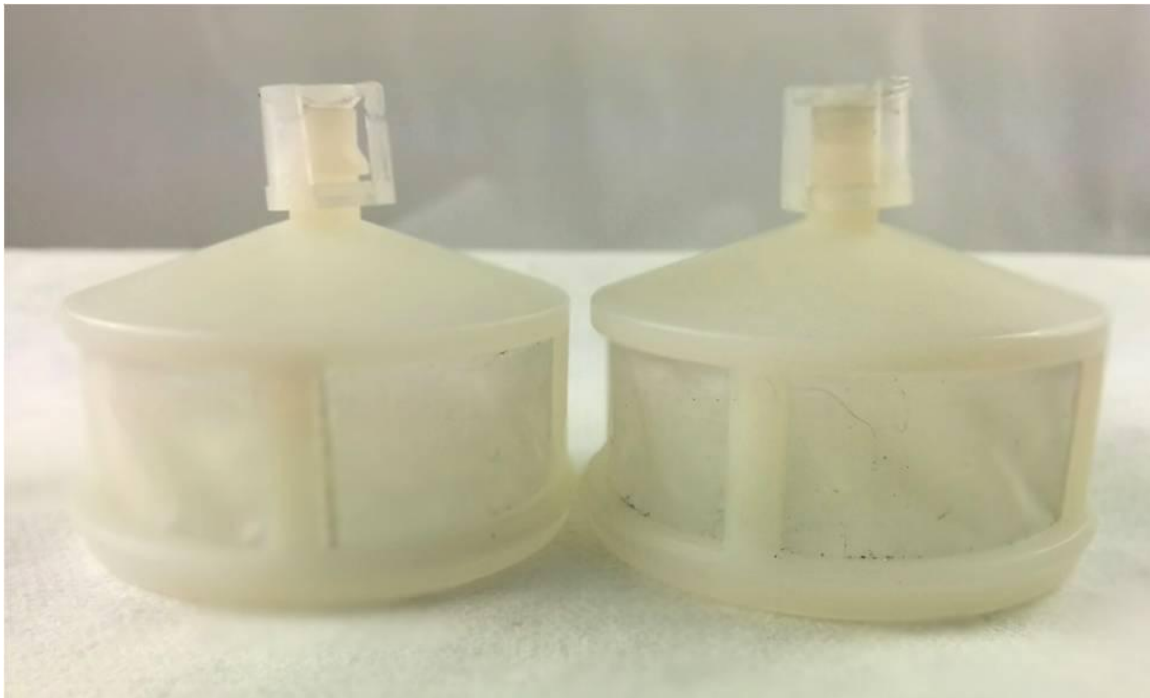
Figure 25. Two Filter Elements from 20,000-cycles of DOT III Fluid Testing

The DOT III brake fluid completed 20,000-cycles of testing without any evidence of deposition on the system filters. The filters from the DOT III fluid testing and the DOT V fluid testing have been removed from the Hydraulic Power Brake system reservoirs and are being retained for future testing and are shown in Figure 25.
